**DEPARTMENT OF TRANSPORTATION****DIVISION OF ENGINEERING SERVICES**

Contract #: 04-0120F4Cty: SF/ALA Rte: 80 PM: 13.2/13.9File #: 1.28**WELDING INSPECTION REPORT****Resident Engineer:**Siegenthaler, Peter**Address:** 333 Burma Road**City:** Oakland, CA 94607**Report No:** WIR-018520**Date Inspected:** 08-Dec-2010**Project Name:** SAS Superstructure**OSM Arrival Time:** 1000**Prime Contractor:** American Bridge/Fluor Enterprises, a JV**OSM Departure Time:** 1830**Contractor:** American Bridge/Fluor Enterprises, a JV**Location:** Job Site**CWI Name:** William Sherwood**CWI Present:** Yes No**Inspected CWI report:** Yes No N/A**Rod Oven in Use:** Yes No N/A**Electrode to specification:** Yes No N/A**Weld Procedures Followed:** Yes No N/A**Qualified Welders:** Yes No N/A**Verified Joint Fit-up:** Yes No N/A**Approved Drawings:** Yes No N/A**Approved WPS:** Yes No N/A**Delayed / Cancelled:** Yes No N/A**Bridge No:** 34-0006**Component:** Orthotropic Box Girder**Summary of Items Observed:**

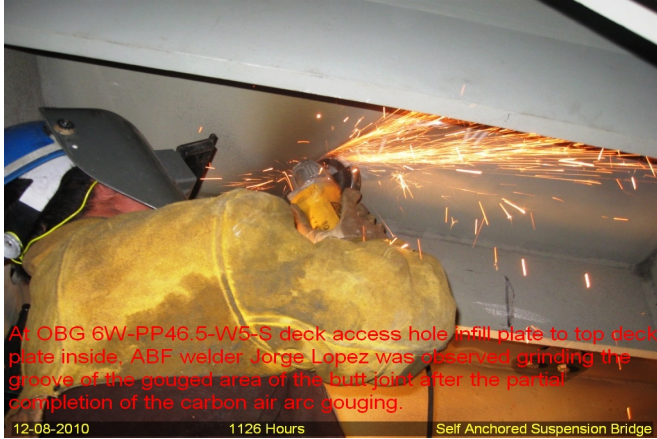
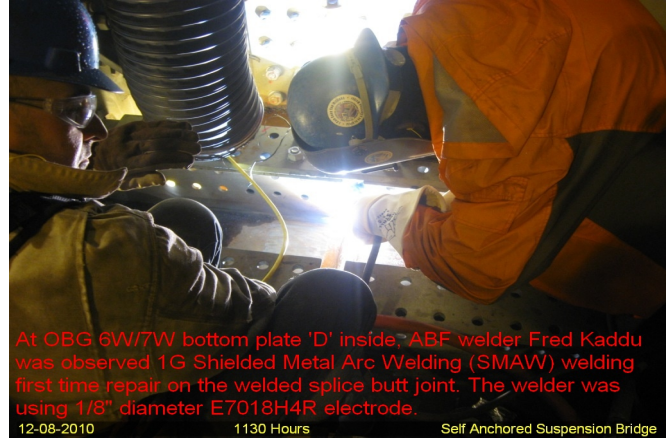
At OBG 6W/7W bottom plate 'D1' inside, QA randomly observed ABF/JV qualified welder Fred Kaddu ID # 2188 perform CJP groove welding first time repair. The welder was observed welding in the 1G (flat) position utilizing Shielded Metal Arc Welding (SMAW) with 1/8" diameter E7018H4R electrode implementing welding procedure ABF-WPS-D15-1001-Repairs. The two repair excavations located at (D1) Y-dimension 530mm having excavation profile of 120mm long x 25mm wide x 9mm deep and at (D1) Y-dimension 1400mm having excavation profile of 100mm long x 20mm wide x 10mm deep were preheated to more than 140 degree Fahrenheit using propane gas torch prior welding. During the shift, ABF QC William Sherwood was noted monitoring the welder. Prior welding, ABF QC William Sherwood was also observed performing Magnetic Particle Testing (MT) using Parker Contour Probe electromagnetic yoke. At the end of the shift, both repairs were completed.

At OBG 6W-PP46.5-W5-S deck access hole infill plate to top deck plate inside, ABF welder Jorge Lopez was observed back gouging using carbon air arc. After partially completing the back gouging, the welder started grinding the groove of the gouged area using 4 1/2" disc grinder. At the end of the shift, grinding on the groove of the gouged area was still continuing and should remain tomorrow.
